**Flood Control Project Maintenance
Levee Inspections**

Fall 2018 Levee Maintenance Deficiency Summary Report

Sacramento River Basin

Reclamation District No. 0070 Meridian

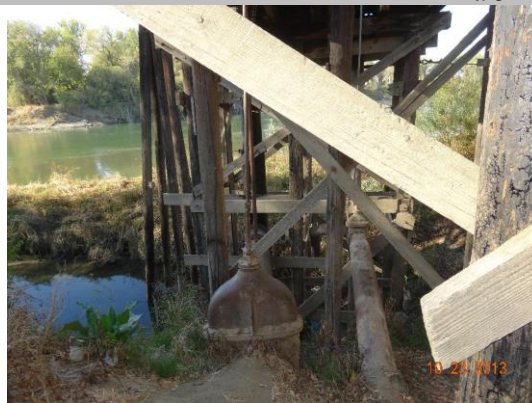
Photo 2 of 3 : UCIP_FA_2018_24108_42465.jpg

View of 16-inch pipe and 24-inch pipe with screw gate located on waterward side.

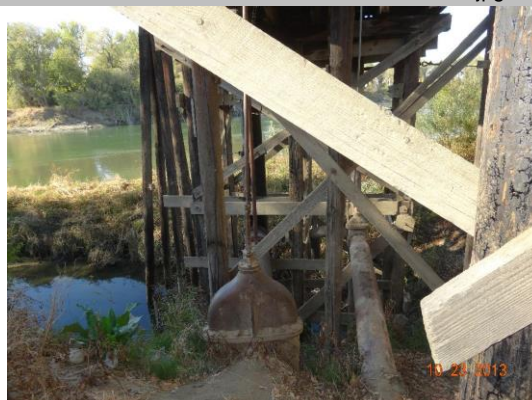
Photo 2 of 3 : UCIP_FA_2018_24107_42458.jpg

View of 16-inch pipe and 24-inch pipe through levee on waterward side.

Comment Code					
Inspector Comment					
FS_ID:24107 DS_ID:21394 EP_NO: N/A Repair Type: Non-Urgent Crossing Status: Found UCIP Comments: This pump station is to be demolished. This crossing will need to be updated once the work has been completed. This crossing is referenced in the USACE Periodic Inspection as item USACE_CESPK_MRD2_2012_p_0433. FIELD_STRUCT_DESC: [Meridian Farms Water Company Pumping Plant No. 3] 3 of 3: 24-inch irrigation discharge pipe of an unknown material through the levee, 20.5 feet below the crown. Gate valve on the waterside (WS) end. Pump on a pile structure in the stream. Wooden walkway to the pump. Concrete distribution box on the landside (LS). (Plans to demolish and remove the existing Meridian Diversion Pumping Facility and the existing Drexler Diversion Pumping Facility and to construct a new Meridian Diversion Pumping Facility with two retractable fish screens and a 72-inch gravity feed intake pipe under the levee authorized under Permit No. 18762, 2013 - Meridian Farms Water Company). [Additional Reference(s): DWR Levee Log, 2007]. FS Date: 10/23/2013

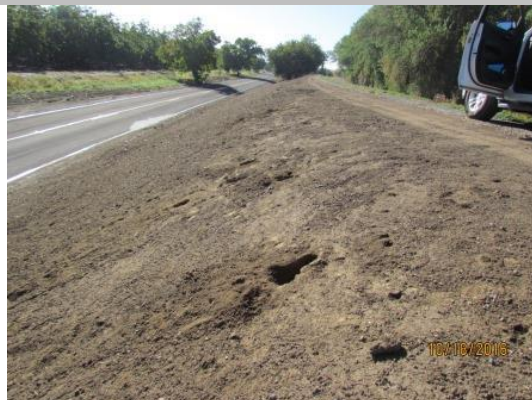
Photo 1 of 1 : FA_2018_RD0070_30_61_20180905_00012.jpg

LM Start	9.28	Rating **	M	Issue No.	61
LM End	9.28	Issue Type +	Ma	Location *	LS
Category	Earthen Levee			GPS Latitude/Longitude	
				Start	End
Item	Animal Control			39.107285 °	39.107285 °
				-121.900753 °	-121.900753 °
DWR ID	DWR_RD0070_02_f_2016_61				
Comment Code					
A3 : No rodents visible, but rodent burrows visible; need to backfill and compact or grout burrows.					
Inspector Comment

View of the rodent holes along the landside slope.

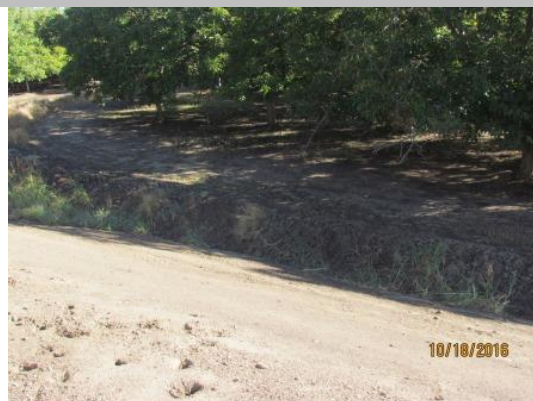
Photo 1 of 1 : FA_2018_RD0070_30_62_20180905_00013.jpg

LM Start	9.57	Rating **	U	Issue No.	62
LM End	9.70	Issue Type +	En	Location *	LS
Category	Earthen Levee			GPS Latitude/Longitude	
				Start	End
Item	Encroachments			39.103192 °	39.101213 °
				-121.899606 °	-121.899380 °
DWR ID	DWR_RD0070_02_f_2016_62				
Comment Code					
DT : Ditch					
Inspector Comment

View of a ditch along the landside toe.

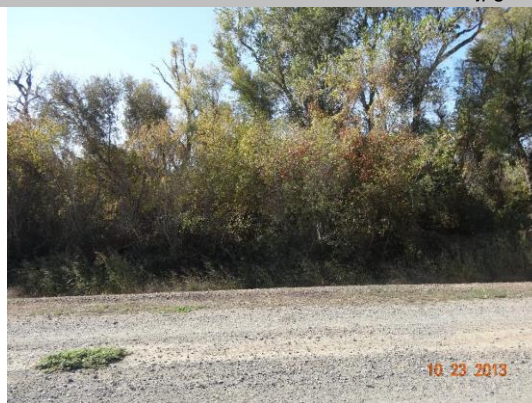
Photo 1 of 3 : UCIP_FA_2018_23967_42129.jpg

Comment Code						
Inspector Comment						
FS_ID:23967 DS_ID:21396 EP_NO: N/A Repair Type: Non-Urgent Crossing Status: Indicator Found UCIP Comments: No evidence of pipe is visible on waterward side. Need to coordinate with owner to determine status of crossing. If crossing is no longer in use owner will need to contact the CVFPB to comply with Title 23. This crossing is referenced in the USACE Periodic Inspection as item USACE_CESPK_MRD2_2012_p_0477. FIELD_STRUCT_DESC: *ABANDONED* 12-inch pipe of an unknown material or purpose through the levee, 3.1 feet below the crown. Siphon breaker in a corrugated metal pipe (CMP) riser on the landside (LS) shoulder. Concrete plug on the LS end. Wooden distribution box on the LS at the discharge end. (Cat. IV-A). [Additional Reference(s): DWR Levee Log, 2007. USACE Sacramento O&M Manual 134, June 1953, (Station 813+00)]. FS Date: 10/23/2013

View of waterward side.

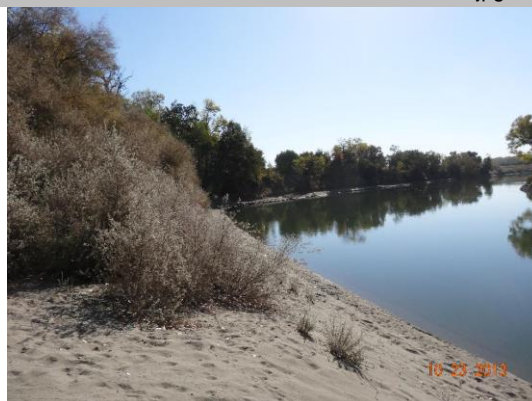
Photo 2 of 3 : UCIP_FA_2018_23967_42132.jpg

Item	DWR UCIP Field Study			39.096935 °	39.096935 °	
				-121.893870 °	-121.893870 °	
DWR ID	21396					
Comment Code						
Inspector Comment						
FS_ID:23967 DS_ID:21396 EP_NO: N/A Repair Type: Non-Urgent Crossing Status: Indicator Found UCIP Comments: No evidence of pipe is visible on waterward side. Need to coordinate with owner to determine status of crossing. If crossing is no longer in use owner will need to contact the CVFPB to comply with Title 23. This crossing is referenced in the USACE Periodic Inspection as item USACE_CESPK_MRD2_2012_p_0477. FIELD_STRUCT_DESC: *ABANDONED* 12-inch pipe of an unknown material or purpose through the levee, 3.1 feet below the crown. Siphon breaker in a corrugated metal pipe (CMP) riser on the landside (LS) shoulder. Concrete plug on the LS end. Wooden distribution box on the LS at the discharge end. (Cat. IV-A). [Additional Reference(s): DWR Levee Log, 2007. USACE Sacramento O&M Manual 134, June 1953, (Station 813+00)]. FS Date: 10/23/2013

No pipe exists levee on waterward side only CMP riser present on landward side.

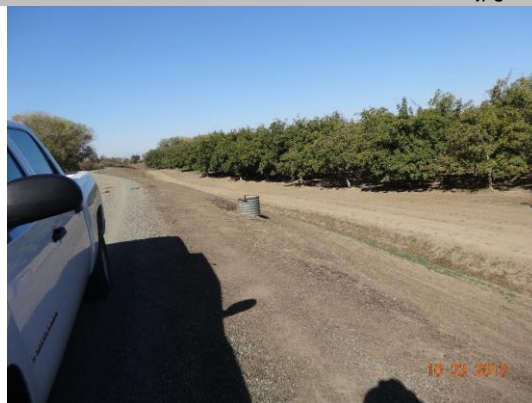
Photo 3 of 3 : UCIP_FA_2018_23967_42131.jpg

CMP riser located on landward shoulder.

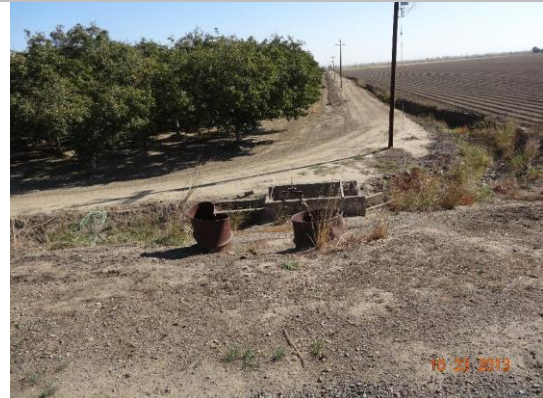
Photo 3 of 3 : UCIP_FA_2018_24195_42688.jpg

Item	DWR UCIP Field Study			39.093712 °	39.093712 °	
				-121.892553 °	-121.892553 °	
DWR ID	21398					
Comment Code						
Inspector Comment						
FS_ID:24195 DS_ID:21398 EP_NO: 1162 Repair Type: Non-Urgent Crossing Status: Found UCIP Comments: Need to verify status of crossing--variation in pipe size. 18 inch pipe listed in desk study and 20 inch pipe found in field. Damage to siphon breaker housing unit. This crossing is referenced in the USACE Periodic Inspection as item USACE_CESPK_MRD2_2012_p_0482. FIELD_STRUCT_DESC: 1 of 2: 20-inch steel irrigation discharge pipe (not 18-inch, as referenced in the permit) through the levee, 3.7 feet below the crown. Concrete cutoff wall around the pipe at each shoulder. Siphon breaker in a steel pipe riser on the landside (LS) shoulder. Slant pump on a wooden pump structure on the waterside (WS). Corrugated metal pipe (CMP) riser under the pump structure at the WS toe. Distribution box at the LS toe. (Plans for the installation of two 18-inch steel discharge pipes through the levee and a pumping plant in the river authorized under Permit No. 1162, 1946 - Homer and Arthur Andreotti). [Additional Reference(s): DWR Levee Log, 2007. USACE Sacramento O&M Manual 134, June 1953, (Station 824+00)]. FS Date: 10/23/2013

View of landward side.

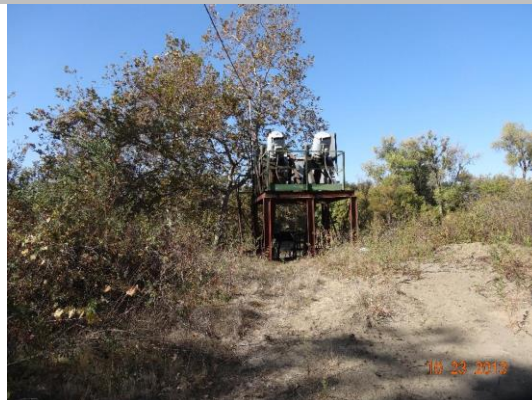
Photo 2 of 3 : UCIP_FA_2018_24196_42692.jpg

FS_ID:24196
DS_ID:21430
EP_NO: 1162
Repair Type: Non-Urgent
Crossing Status: Found
UCIP Comments: Need to verify status of crossing--variation in pipe size. 18 inch pipe listed in desk study and 20 inch pipe found in field. This crossing is referenced in the USACE Periodic Inspection as item USACE_CESPK_MRD2_2012_p_0482.
FIELD_STRUCT_DESC: 2 of 2: 20-inch steel irrigation discharge pipe (not 18-inch, as referenced in the permit) through the levee, 3.7 feet below the crown. Concrete cutoff wall around the pipe at each shoulder. Siphon breaker in a steel pipe riser on the landside (LS) shoulder. Slant pump on a wooden pump structure on the waterside (WS). Corrugated metal pipe (CMP) riser under the pump structure at the WS toe. Distribution box at the LS toe. (Plans for the installation of two 18-inch steel discharge pipes through the levee and a pumping plant in the river authorized under Permit No. 1162, 1946 - Homer and Arthur Andreotti). [Additional Reference(s): DWR Levee Log, 2007. USACE Sacramento O&M Manual 134, June 1953, (Station 824+00)].

Pump station on waterward side dense vegetation on slope.

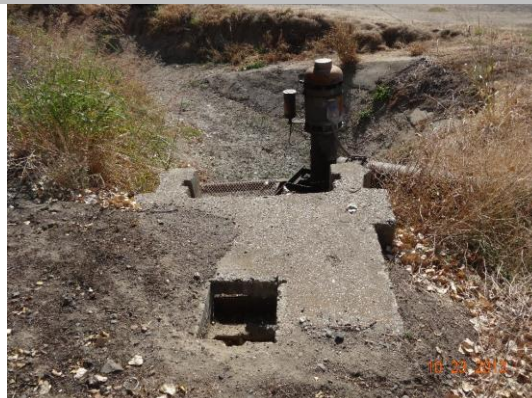
Photo 3 of 3 : UCIP_FA_2018_24197_42697.jpg

FS_ID:24197
DS_ID:21400
EP_NO: 9986
Repair Type: Non-Urgent
Crossing Status: Indicator Found
UCIP Comments: Need to coordinate with owner to determine status of crossing. If crossing is no longer in use owner will need to contact the CVFPB to comply with Title 23. This crossing is referenced in the USACE Periodic Inspection as item USACE_CESPK_MRD2_2012_p_0527.
FIELD_STRUCT_DESC: *ABANDONED* 30-inch steel irrigation discharge pipe through the levee, 27.5 feet below the crown. Two electric gate valves in a concrete pit on the waterside (WS) end, at the end of the discharge pipe. Two slant pumps on the WS slope. Control switches in a corrugated metal shed at the WS shoulder. (Plans for the installation of two inclined turbine pumps, a gate valve, a 50-horsepower pump, and an electrical conduit authorized under Permit No. 5193, 1965 - Meridian Farms Water Company. Retention of a 30-inch steel pipe through the levee, 27.5 feet below the crown, two gate valves, two slant pumps, and a metal building with switch panels authorized under Automatic Board Order (ABO) issued as Permit No. 9986, 1974 - Meridian Farms Water Company. Plans to abolish existing pumping plant and to abandon existing pipeline at RM 125.8 and to construct a new pumping plant at RM 127.0 consisting of two 30-inch intake pipes supported by seven 10-inch by 10-inch H beams, a fish screen, and a 36-inch pipe trenched through the levee, and to place riprap on the slope authorized under Permit No. 18323, 2009 - Meridian Farms Water Company). [Additional Reference(s): DWR Levee Log, 2007. USACE Sacramento O&M Manual 134, June 1953, (Station 889+72)].

View of concrete slab with pump located on landward side.

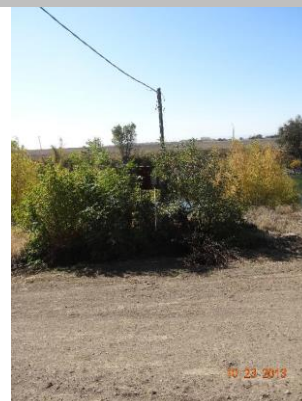
Photo 1 of 3 : UCIP_FA_2018_47033_42141.jpg

Comment Code						
Inspector Comment						
FS_ID:47033						
DS_ID:21402						
EP_NO: 9997						
Repair Type: Non-Urgent						
Crossing Status: Found						
UCIP Comments: Debris found on waterward side along berm running parallel to levee. Two crossing found--Need to coordinate with owner to determine permit for second crossing and status of crossing. If crossing is no longer in use owner will need to contact the CVFPB to comply with Title 23. Dense vegetation limits the inspector's visibility to identify signs of pipe failure (leaks) along the waterward slope. Recommend removing vegetation along pipe alignment to conduct proper inspection of structure and appurtenances. This crossing is referenced in the USACE Periodic Inspection as item USACE_CESPK_MRD2_2012_p_0559.						
FIELD_STRUCT_DESC: 12-inch steel irrigation discharge pipe through the levee, 3.5 feet below the crown. Siphon breaker in a corrugated metal pipe (CMP) riser on the landside (LS) shoulder. Pump and control valve on the waterside (WS). Power pole on the WS shoulder. Discharge box at the LS toe. (Retention of a 12-inch steel pipe through the levee, 3.5 feet below the crown, a pump, a control valve, a siphon breaker, and a discharge box authorized under Automatic Board Order (ABO) issued as Permit No. 9997, 1974 - H. and Anne M. Rohleder).

Crossing appurtenances located near brush and power pole on waterward side.

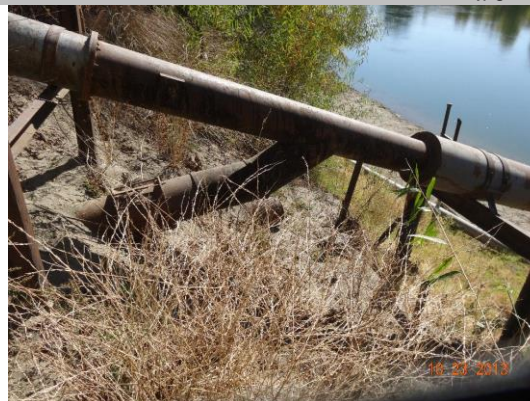
Photo 2 of 3 : UCIP_FA_2018_47033_42139.jpg

Pipe crossing on waterward side. Second pipe comes out approximately 3 feet downstream from this crossing.

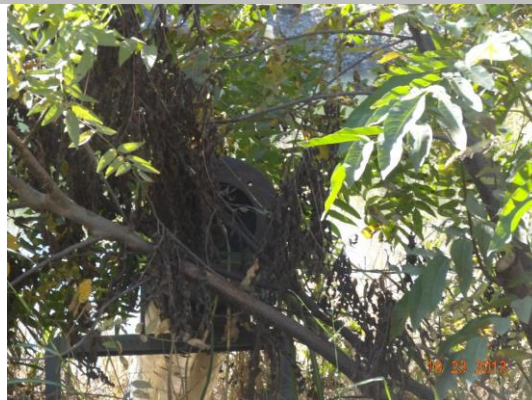
Photo 3 of 3 : UCIP_FA_2018_47033_42143.jpg

Item	DWR UCIP Field Study			39.072540 °	39.072540 °	
				-121.887807 °	-121.887807 °	
DWR ID	21402					
Comment Code						
Inspector Comment						
FS_ID:47033 DS_ID:21402 EP_NO: 9997 Repair Type: Non-Urgent Crossing Status: Found UCIP Comments: Debris found on waterward side along berm running parallel to levee. Two crossing found--Need to coordinate with owner to determine permit for second crossing and status of crossing. If crossing is no longer in use owner will need to contact the CVFPB to comply with Title 23. Dense vegetation limits the inspector's visibility to identify signs of pipe failure (leaks) along the waterward slope. Recommend removing vegetation along pipe alignment to conduct proper inspection of structure and appurtenances. This crossing is referenced in the USACE Periodic Inspection as item USACE_CESPK_MRD2_2012_p_0559. FIELD_STRUCT_DESC: 12-inch steel irrigation discharge pipe through the levee, 3.5 feet below the crown. Siphon breaker in a corrugated metal pipe (CMP) riser on the landside (LS) shoulder. Pump and control valve on the waterside (WS). Power pole on the WS shoulder. Discharge box at the LS toe. (Retention of a 12-inch steel pipe through the levee, 3.5 feet below the crown, a pump, a control valve, a siphon breaker, and a discharge box authorized under Automatic Board Order (ABO) issued as Permit No. 9997, 1974 - H. and Anne M. Rohleder). [Additional Reference(s): DWR Levee Log, 2007. USACE Sacramento O&M Manual 134, June 1953, (Station 930+22)]. FS Date: 10/23/2013

Pipe section exposed unable to determine if it is still in use.

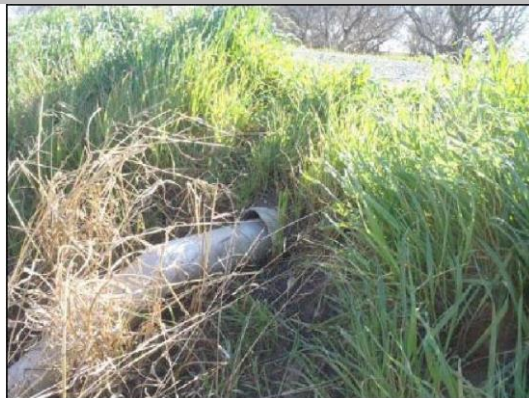
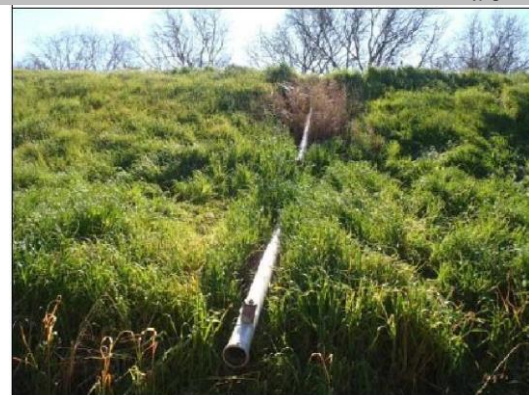
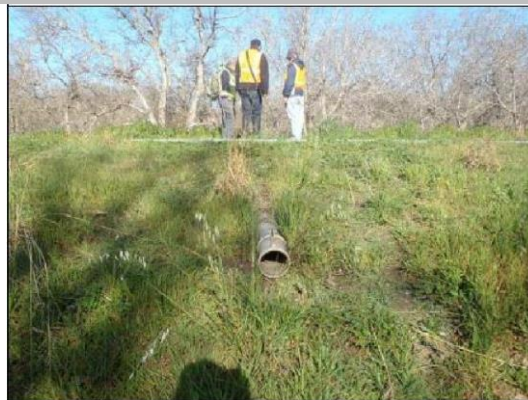
Photo 1 of 3 : UCIP_FA_2018_50086_42883.jpg

Comment Code						
Inspector Comment						
FS_ID:50086 DS_ID:24744 EP_NO: N/A Repair Type: Non-Urgent Crossing Status: Found UCIP Comments: 07/07/2016 Dense vegetation on both slopes. No damage was observed on levee slopes or crown, crossing was downgraded from Urgent to Non-Urgent. No permit found for crossing. Need to recheck during winter. According to Andy Duffey, District Representative, CVFPB has issued a enforcement letter to owner dated 6/23/2016. (DWR UCIP - omagana)10/23/2013 No records were found during initial desk study--need to contact owner to obtain permit number authorizing work. Owner will need to coordinate with DWR Inspector and CVFPB to remove crossing according to Title 23 requirements. (DWR UCIP - omagana) FIELD_STRUCT_DESC: 6-inch aluminum irrigation pipe sleeved through a 10-inch corrugated metal pipe through the levee, 1.5 feet below the crown. Annular space not grouted. Pipe extends down both slopes about 2 feet below the crown. FS Date: 7/7/2016 10:39:00 AM

View of pipe through levee--photo is from USACE PI Draft Report dated 6-2012.

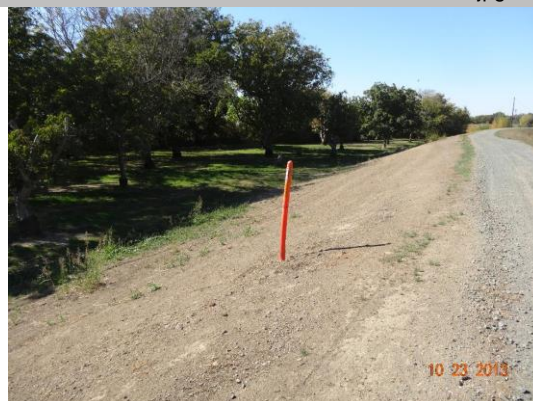
Photo 1 of 3 : UCIP_FA_2018_23984_42172.jpg

Comment Code						
Inspector Comment						
FS_ID:23984 DS_ID:21403 EP_NO: 3800 Repair Type: Non-Urgent Crossing Status: Indicator Found UCIP Comments: Need to contact owner to determine if crossing is still active and to determine last inspection date. Will need copy of letter showing crossings passed inspection. This crossing is referenced in the USACE Periodic Inspection as item USACE_CESPK_MRD2_2012_p_0568. FIELD_STRUCT_DESC: 20-inch coated steel natural gas pipeline through the levee, 3 feet below the crown. Concrete cutoff wall around the pipe at the center of the levee. Marker sign on the waterside (WS) shoulder. Natural gas equipment pad at the landside (LS) toe. (Plans to construct and maintain a 20-inch gas line across the Sacramento River authorized under Permit No. 3800, 1961 - Pacific Gas and Electric Company [PG&E]). [Additional Reference(s): DWR Levee Log, 2007]. FS Date: 10/23/2013

Marker located on waterward side.

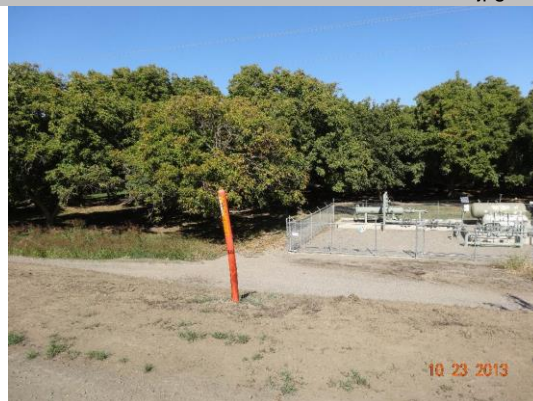
Photo 2 of 3 : UCIP_FA_2018_23984_42171.jpg

Marker on landward side.

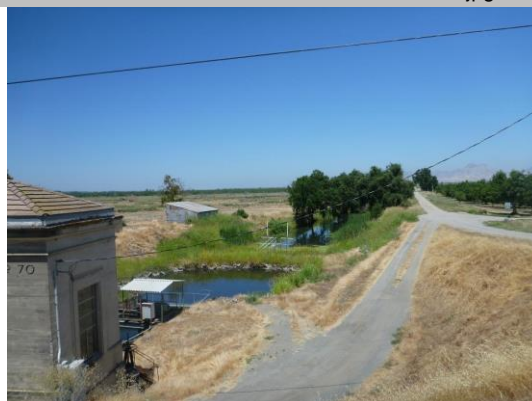
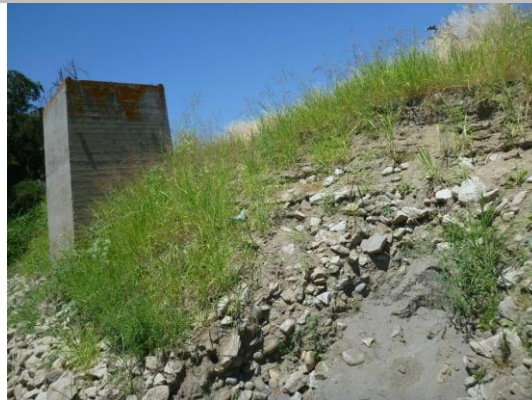
Photo 1 of 3 : LEVAL_FA_2018_152_1717.jpg

LM Start	13.83	Rating **	A/W	Issue No.	75
LM End	13.83	Issue Type +	Ma	Location *	
Category	Supplemental			GPS Latitude/Longitude	
				Start	End
Item	2017 Storm Damage			39.068190°	39.068190°
				-121.862700°	-121.862700°
DWR ID	DWR_RD0070_02_f_2017_75				
Comment Code					
Inspector Comment					
Levee Evaluation Comments					
Description:					
Site ID No:152					
Site Designation:RD 70-01					
Repair Type: Erosion					
Rating:Area of Concern					
Field Date:7/17/2017					
Notes: bank slope erosion around a drainage pipe/box

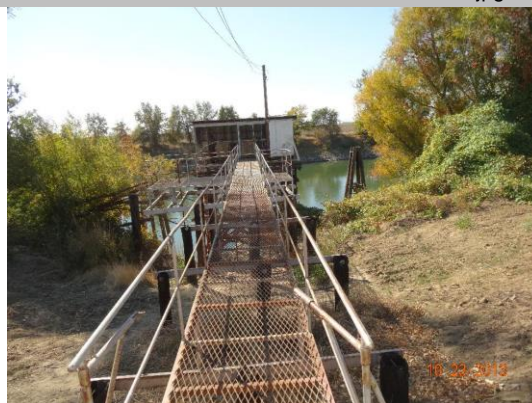
Photo 1 of 3 : UCIP_FA_2018_24229_42848.jpg

Comment Code					
Inspector Comment					
FS_ID:24229 DS_ID:21421 EP_NO: 9990 Repair Type: Non-Urgent Crossing Status: Found UCIP Comments: Need to determine if crossings are still being used. This crossing is referenced in the USACE Periodic Inspection as item USACE_CESPK_MRD2_2012_p_0685. FIELD_STRUCT_DESC: 1 of 2: 24-inch steel irrigation discharge pipe sleeved through a 30-inch coated steel pipe through the levee, 24 feet below the crown. Gate valve on the waterside (WS) end. Concrete headwall with a flap gate on the landside (LS). Pump on a pile structure in the stream. Wooden walkway to the pump. (Retention of two 24-inch steel pipes through the levee, 24 feet below the crown, two pumps, and two gate valves authorized under Automatic Board Order (ABO) issued as Permit No. 9990, 1974 - Newhall Land and Farming Company). [Additional Reference(s): DWR Levee Log, 2007. USACE Sacramento O&M Manual 134, June 1953, (Station 1086+55)]. FS Date: 10/23/2013

Walkway and pump house on waterward side.

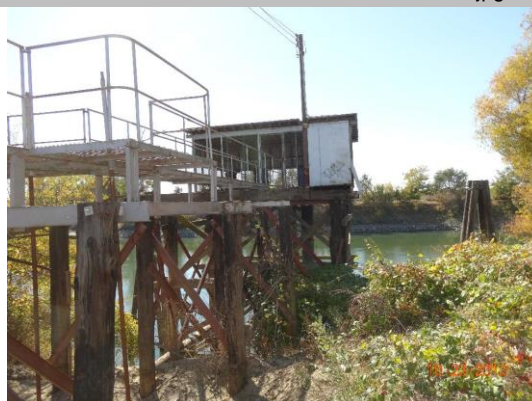
Photo 2 of 3 : UCIP_FA_2018_24229_42849.jpg

Pump house located on waterward side.

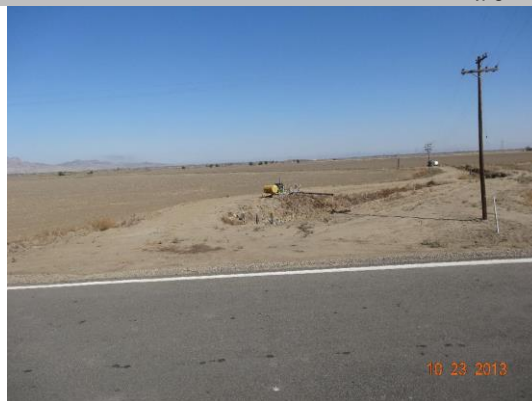
Photo 3 of 3 : UCIP_FA_2018_24229_42853.jpg

Overview of landward side.

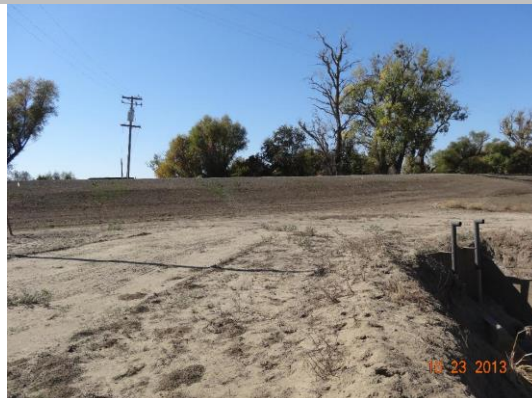
Photo 3 of 3 : UCIP_FA_2018_24231_42860.jpg

View of landward side photo taken from concrete headwall.
